SUBJECT : SAFETY OF HILL SLOPES AROUND NAINI TAL.

Geological report on the stability of the Hillside at Naini-Tal by Mr. J.B. Auden.

**REPORT**  
ON THE  
**SAFETY OF CERTAIN AREAS**  
IN  
**NAINI TAL**  
**1939**

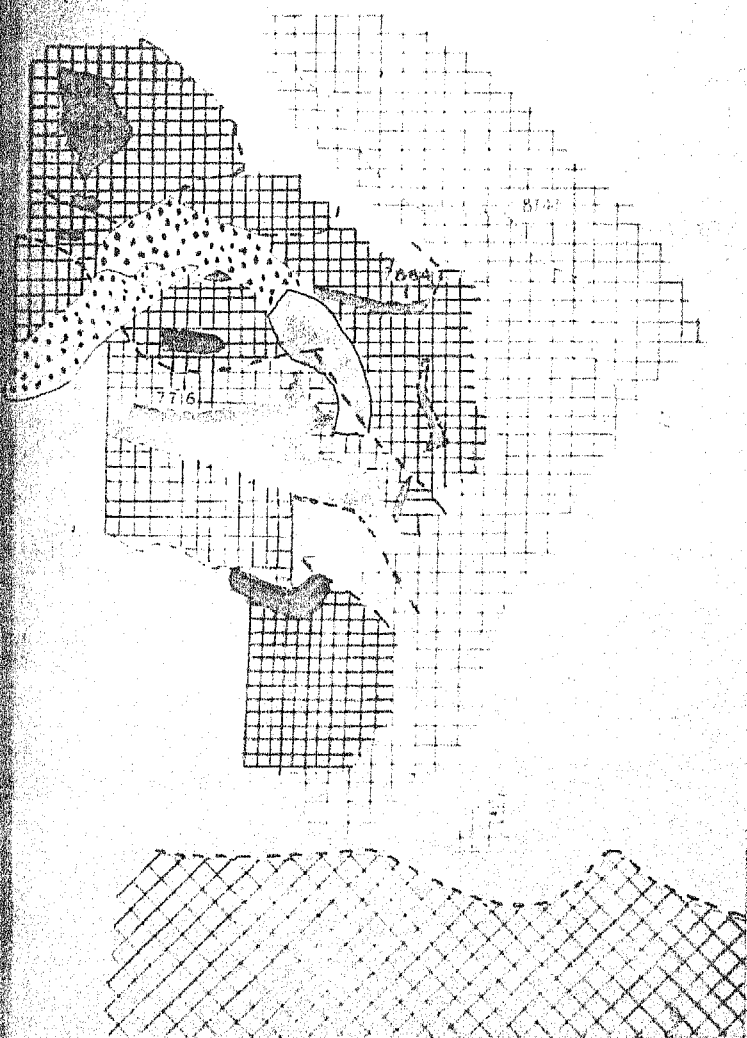
# PROVISIONAL GEOLOGICAL MAP OF NAINI TAL

utilised instead, partly for the purer lime which would be obtained from the non-dolomitic rocks and partly to eliminate the possibility of slips east of Deopatha. Unfortunately, however, the limestone dip towards the south-west and quarrying on the west face of China would lead to accidents by the slipping down of blocks along the bedding planes. A precaution that can be taken to see that only loose boulders of dolomite should be used for lime burning, <sup>and</sup> not those the removal of which would lead to slope instability. The workmen should be allowed to blast.
